Intermittent No Crank/No Start, No Module Communication, MIL, Warning Lights, Vehicle Messages or DTCs Set by Various Control Modules – Diagnosing and Repairing Fretting Corrosion (Disconnect Affected Connector and Apply Dielectric Lubricant)

2013 and Prior GM Passenger Cars and Trucks

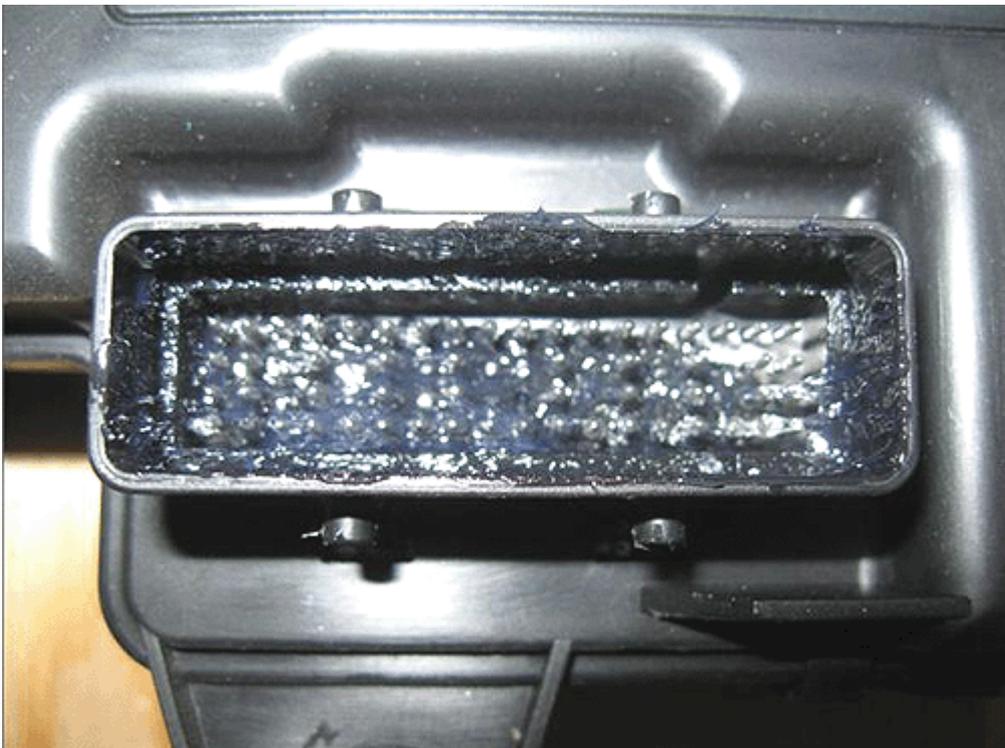
Fretting corrosion looks like little dark smudges on electrical terminals and appear where the actual electrical contact is being made. In less severe cases it may be unable to be seen or identified without the use of a magnifying glass.

DO NOT apply an excessive amount of dielectric lubricant to the connector as shown, as hydrolock may result when attempting to mate the connector.

With a one-inch nylon bristle brush, apply dielectric lubricant to both the module/component side and the harness side of the affected connector.
